CAPSIZING/SWAMPING ACCIDENT INVESTIGATIONS FOR 1975 SEASON.(U)

Report No. CG-D-17-77

CAPSIZING/SWAMPING
ACCIDENT INVESTIGATIONS FOR
1975 SEASON

FINAL REPORT

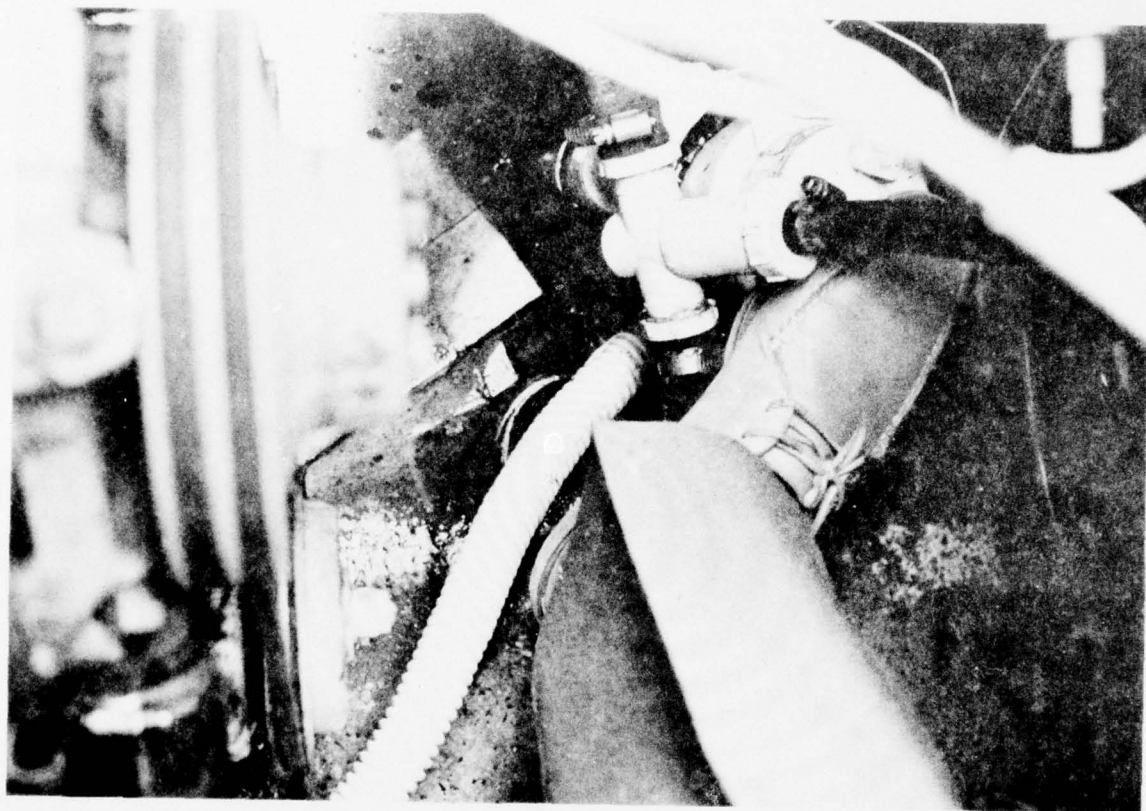
the bilge for servicing the engine. As a result the fuel lines were quite susceptible to damage.

Figure 9. Water Supply Line Susceptible To Damage

The first two problems could be remedied by regulation if they are found to occur frequently. The third could be attacked by regulation or education.

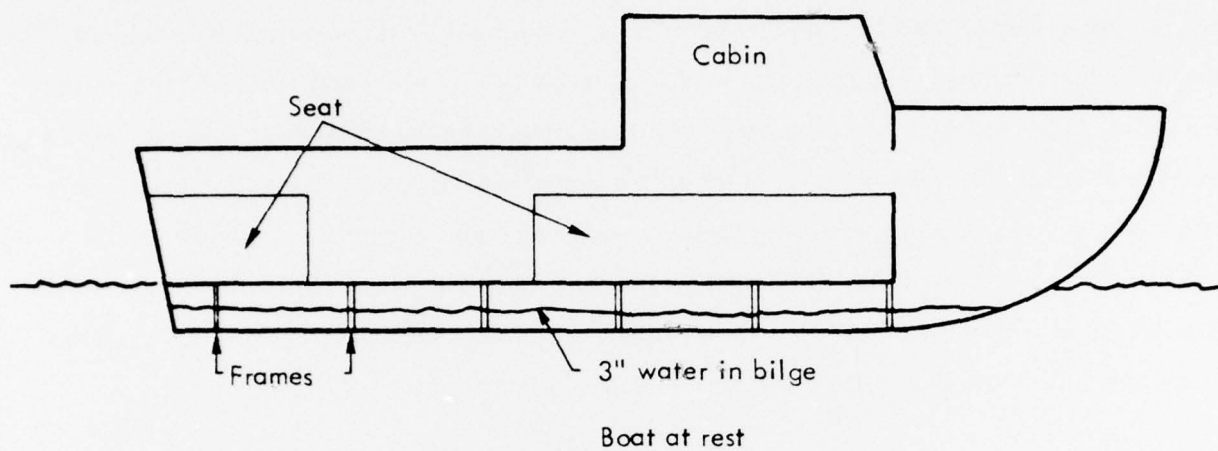
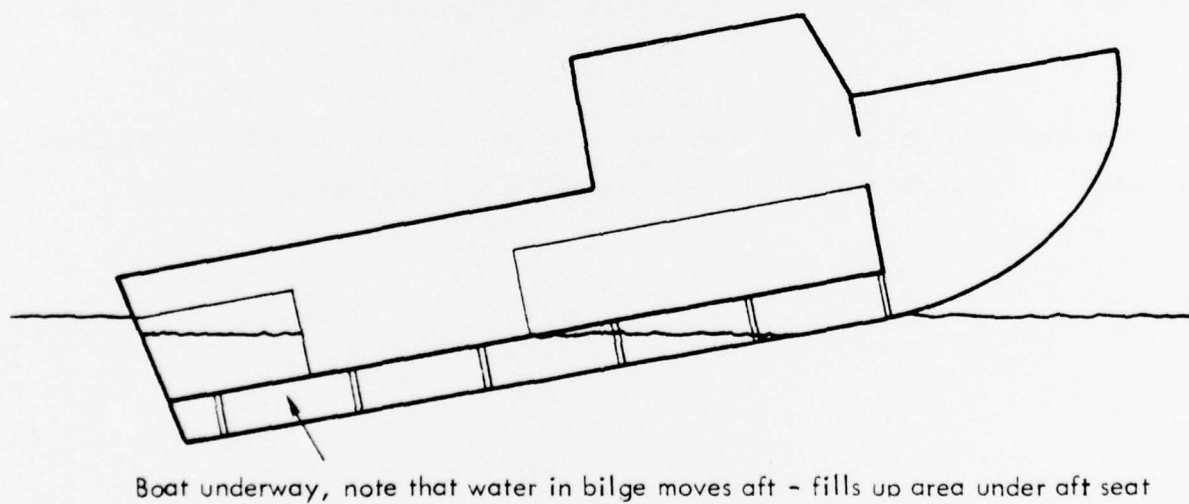
Figure 1. Configuration of Boat

When inspected, the boat was back in operation and was at dock ready to be rented. There was about three inches of water in the bilge, with no good way to get it out. The water was noticeable by going forward and looking into the storage area under the foredeck. If the water covered the flatbottom 14 ft long, five ft wide, and was three in. deep through, the bilge would have 17.5 cu ft or 1120 lb of water. If that much water had been in the boat at the time of the subject rental, the reportedly poor performance could be explained. See Figure 1.

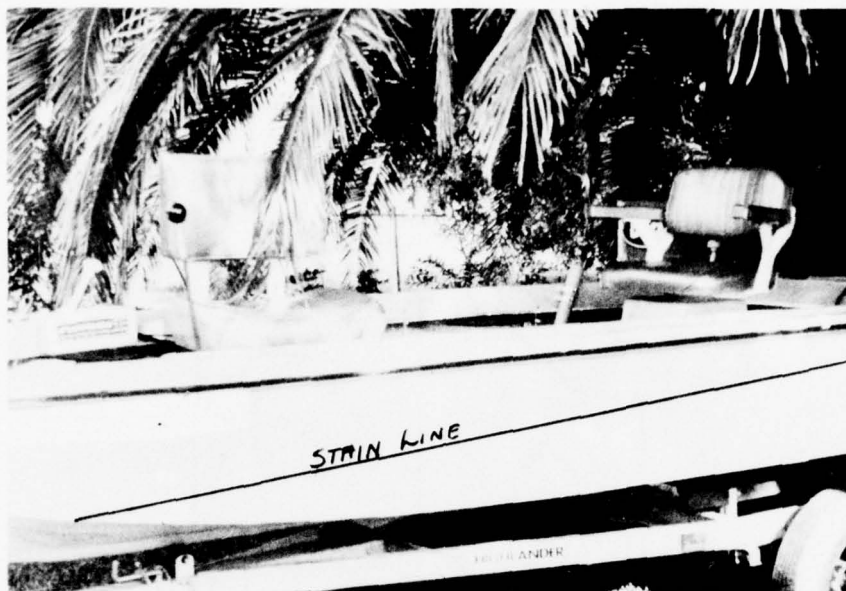
Figure 4. Stain Line Indicating Improper Loading

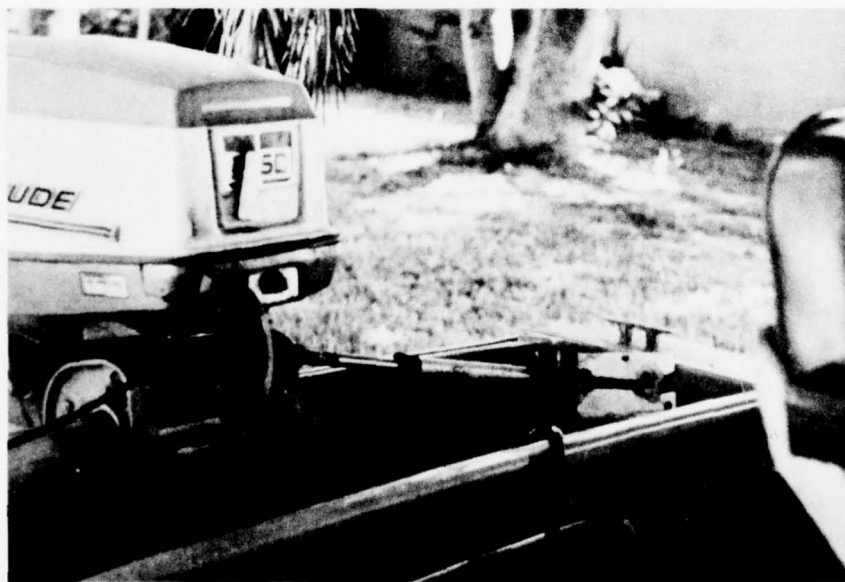
Figure 5. Modification

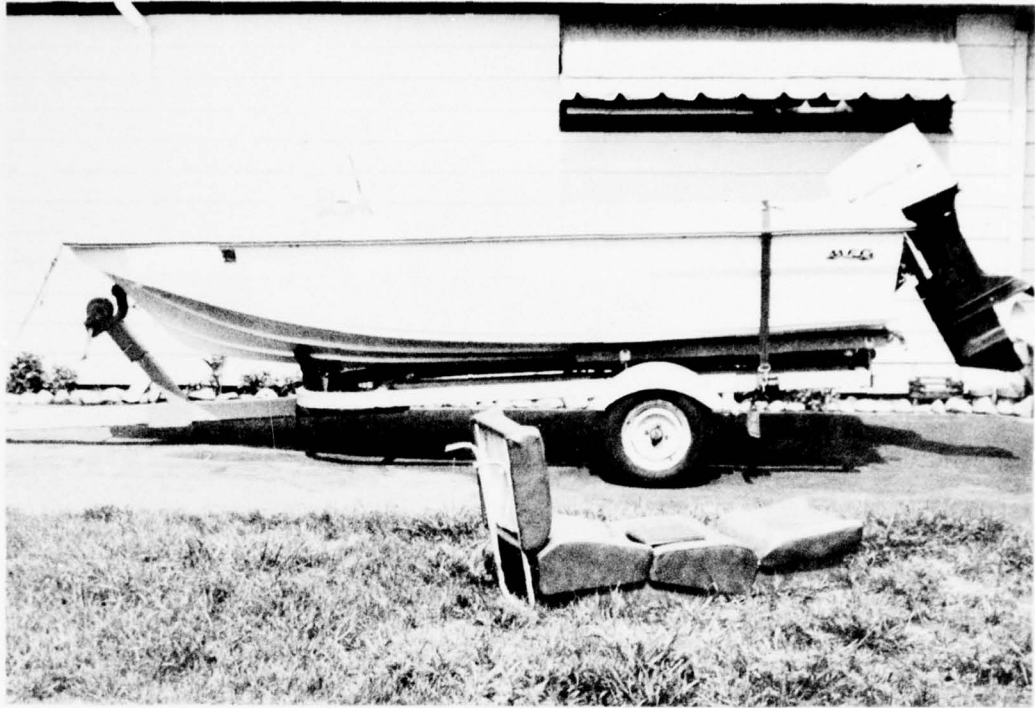
Figure 5. Profile - Note Windshield and Outboard Motor Were Replaced Since Accident.

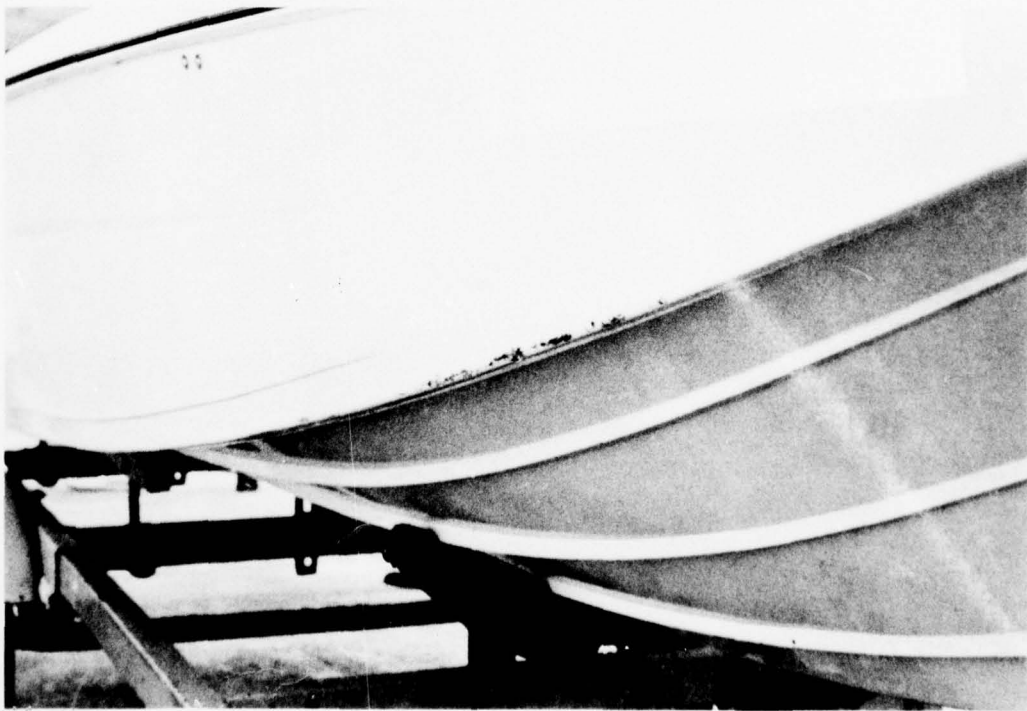
Figure 6. Gelcoat Damage

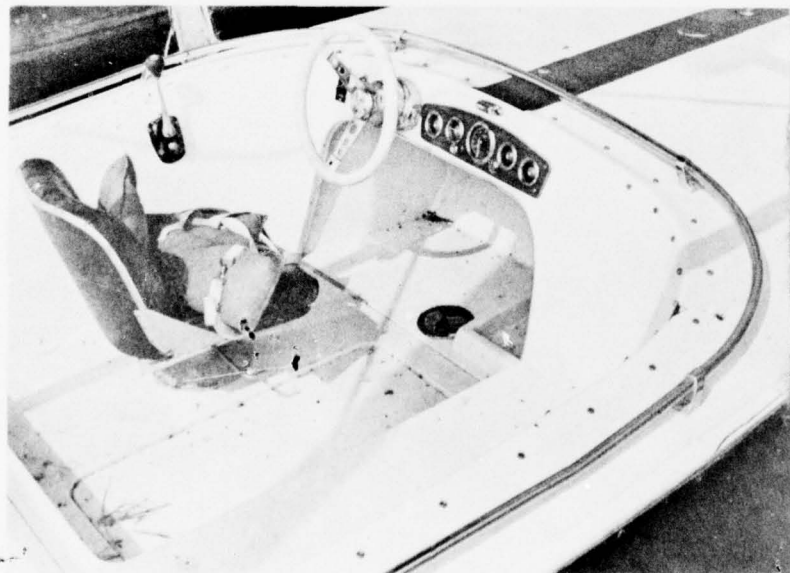
Figure 4. Cockpit Area - Runabout - Note Kink In Rail Where Operator's Jaw Impacted, Also Note Cracks In Fiberglass

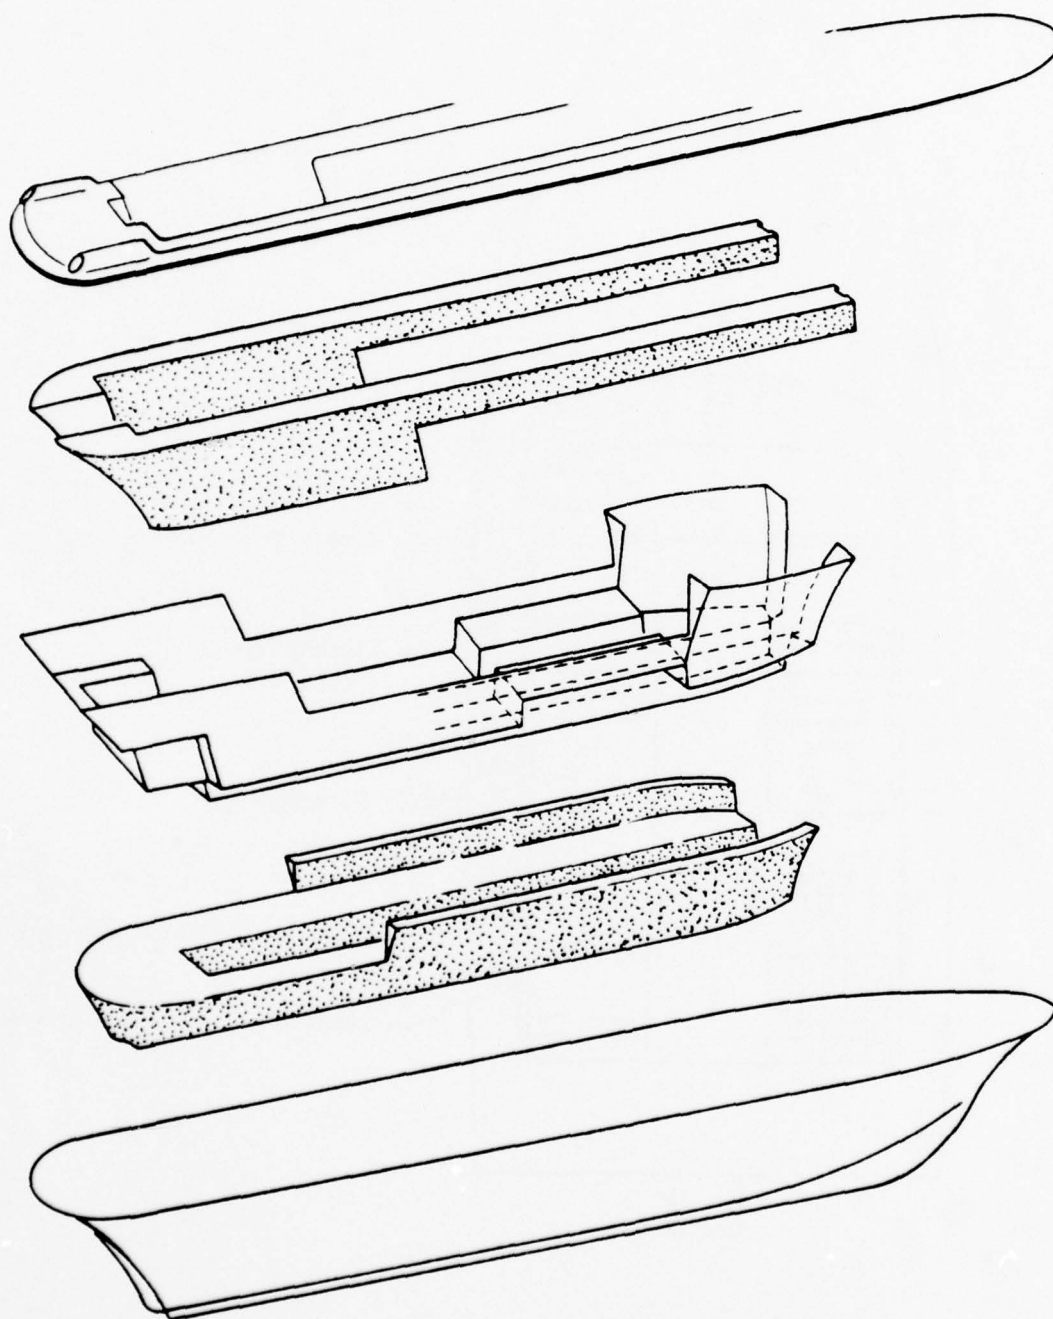
Figure 3. Foam Distribution

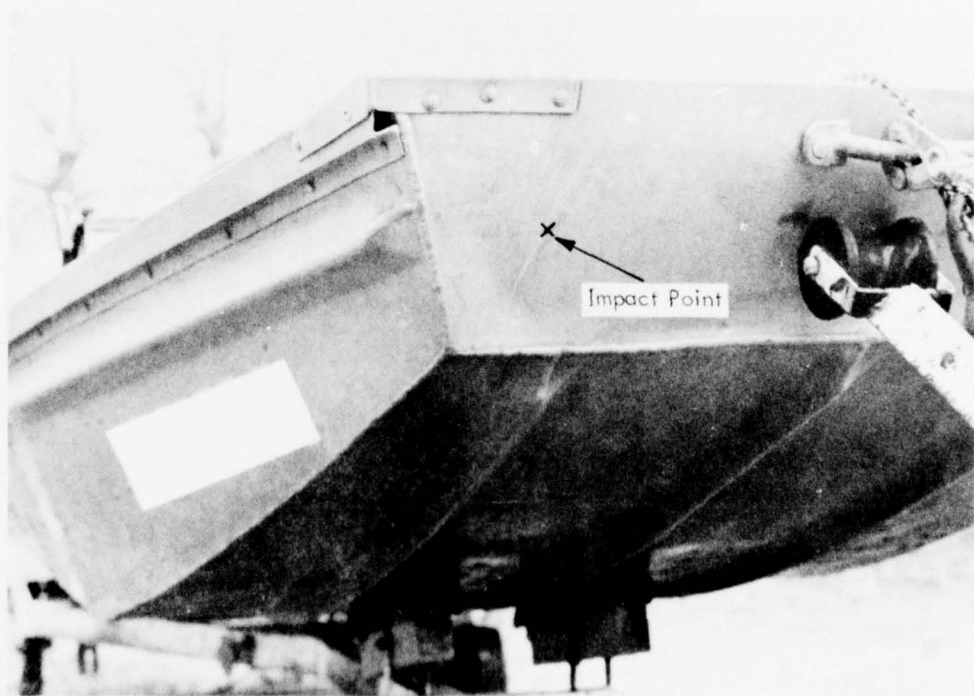
PHOTOGRAPH 12. DAMAGED AREA
